# Hill County

## HIGH HAZARD LOCATION STUDY

Robert Peccia &  
Associates

December 1982

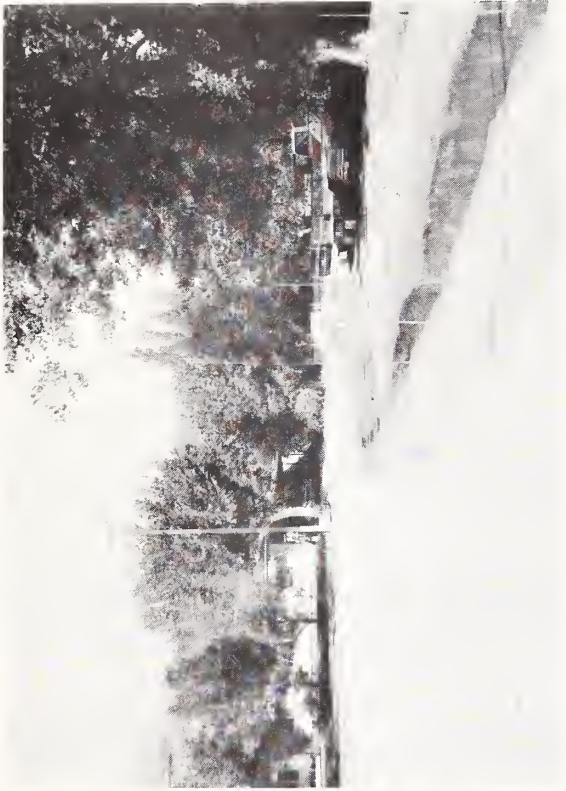
View of north approach to the intersection.

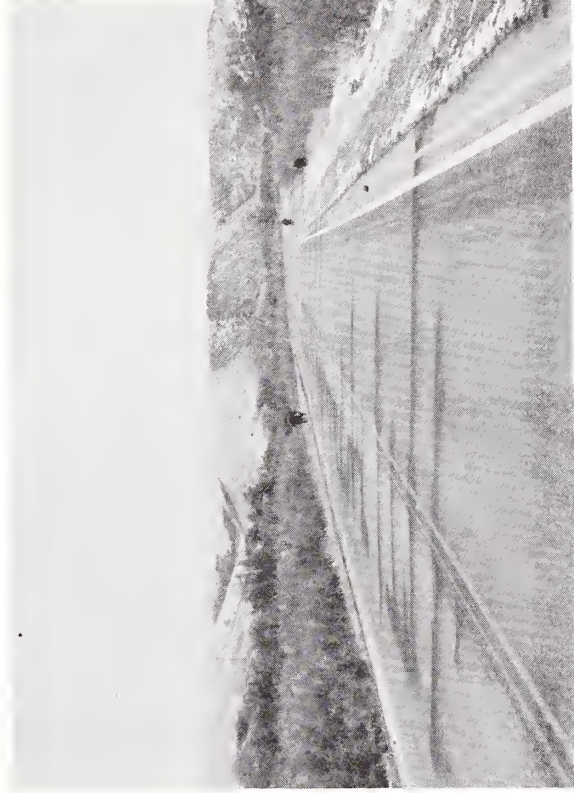
Typical situation facing driver passing through this section of Beaver Creek Park.

Undoubtedly the single most hazardous situation associated with this roadway results from cattle on or near the roadway. Area ranchers frequently graze cattle within Beaver Creek Park through leasing arrangements with Hill County. This practice provides Hill County with a major source of revenue for operation and maintenance of the park throughout the year. Due to the cost of park operations, this policy can be expected to continue. A contributing factor to the hazard of cattle on or near the roadway is the thickness of roadside vegetation, which forces cattle to move along the shoulder where walking is much easier. Hill County recently initiated a policy of trimming back vegetation approximately 15 feet from the edge of the roadway. This practice makes cattle more visible to motorists and reduces the number of "hiding spots" near the roadway edge. In addition, the trimming of roadside vegetation has also served to increase sight distance in some instances. Typical site conditions are depicted in Plates 3A and 3B.

1. In the summer of 1982, the County began a program of cutting back vegetation to 15 feet from the edge of the roadway. This is by far the most effective means of reducing vehicle/animal collisions. It is strongly recommended that this type of maintenance be continued in the future. According

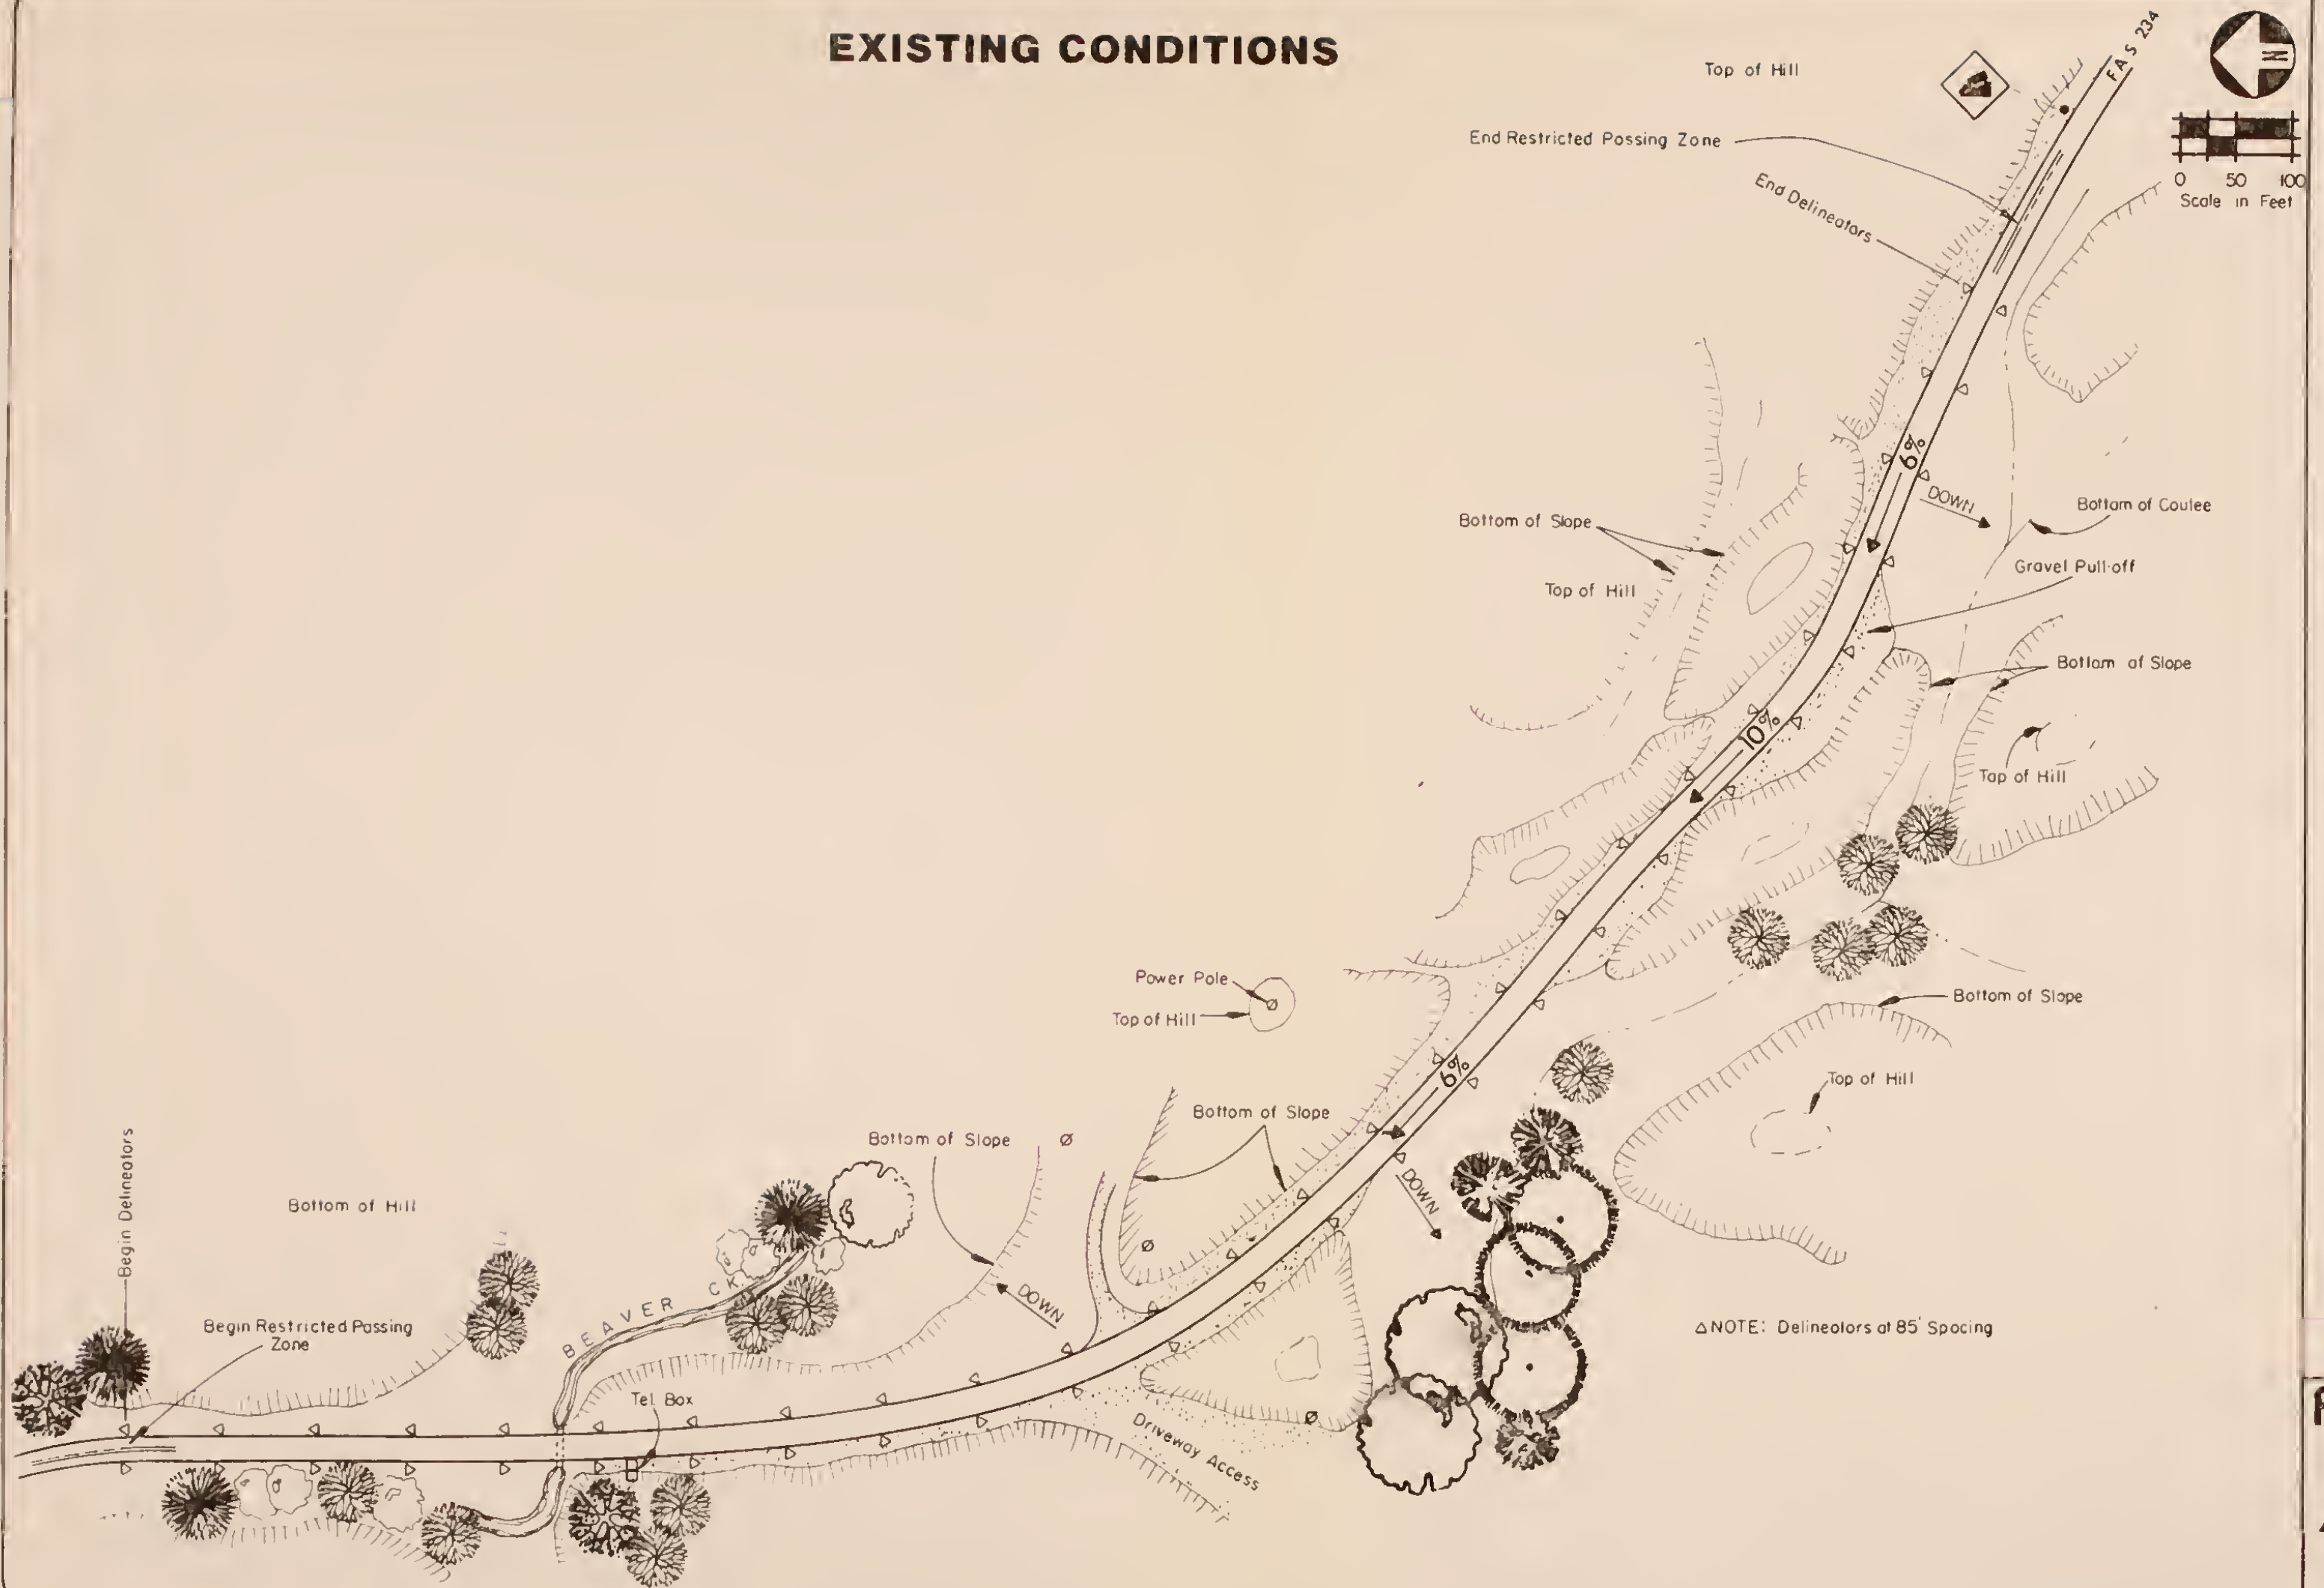
Figure No.  
**4-B**  
Hill Co.

A total of four accidents, all of which occurred during 1978, were reported in the Rotary Hill area during the study period. These accidents resulted in injuries to one person. Local officials have indicated that numerous accidents, including one fatality, have occurred at this site during the past few years. These accidents appear to be either unreported or beyond the limits of the accident study period. All of the four reported accidents were

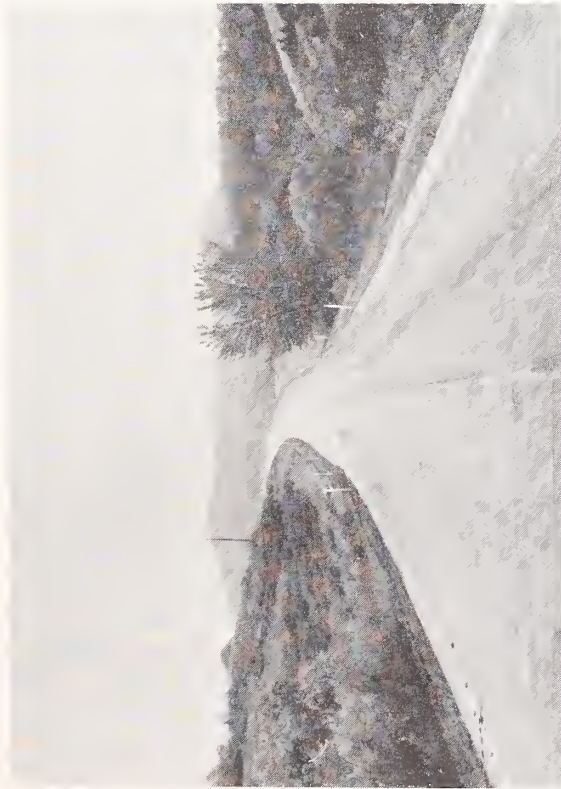
Looking at the north approach to Rotary Hill. Delineators spaced approximately 90 feet apart.

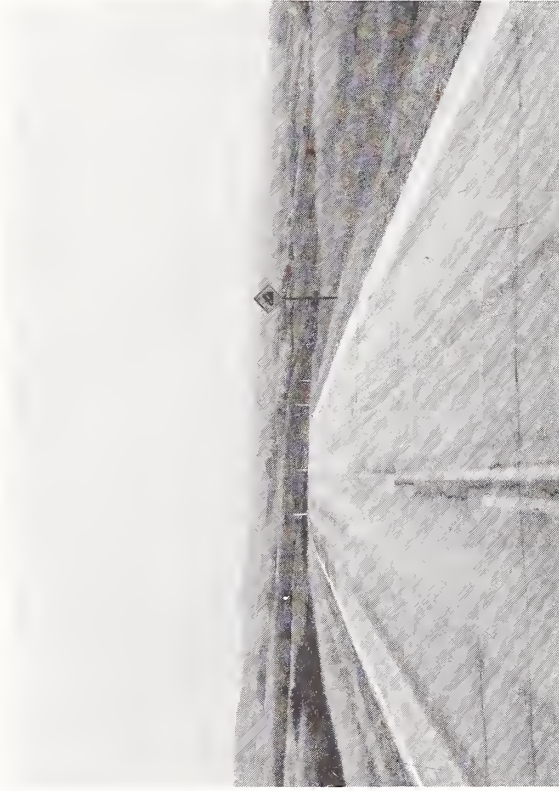
View of north approach to Rotary Hill. Note pavement markings and the high visibility of roadside delineators.
